TWO-DIMENSIONAL ELECTRIC IMAGING: A NON-INVASIVE TOOL FOR HELPING HYDROGEOLOGICAL AND GEOTECHNICAL PROBLEMS IN URBAN AREAS

Jorge L. Abril Benjumea

ABSTRACT. Two-dimensional electrical images of resistivity and time-domain induced polarization (IP) in conjunction with standard penetration tests (SPTs) were used to investigate the subsurface drainage patterns and the stability of underground geological structures in two endangered earth-sloping areas, referred as LEM (Luiz Eduardo Magalhães) and LVF (Luiz Viana Filho). They are located along new streets cutting across hill slopes with thick clayed and silt-sand weathering products, which are potentially susceptible to water seepages and landslides. The Schlumberger electrode array was used to obtain well-controlled geo-electrical soundings for two geophysical traverses extending across the unstable zone in the LEM damaged area. A dipole-dipole array was used to survey three geo-electrical traverses extending across the water-seeping LVF area. The constructed pseudosections of apparent resistivity and chargeability were automatically inverted using the RES2DINV package, controlled by SPT and lithological data from samples collected

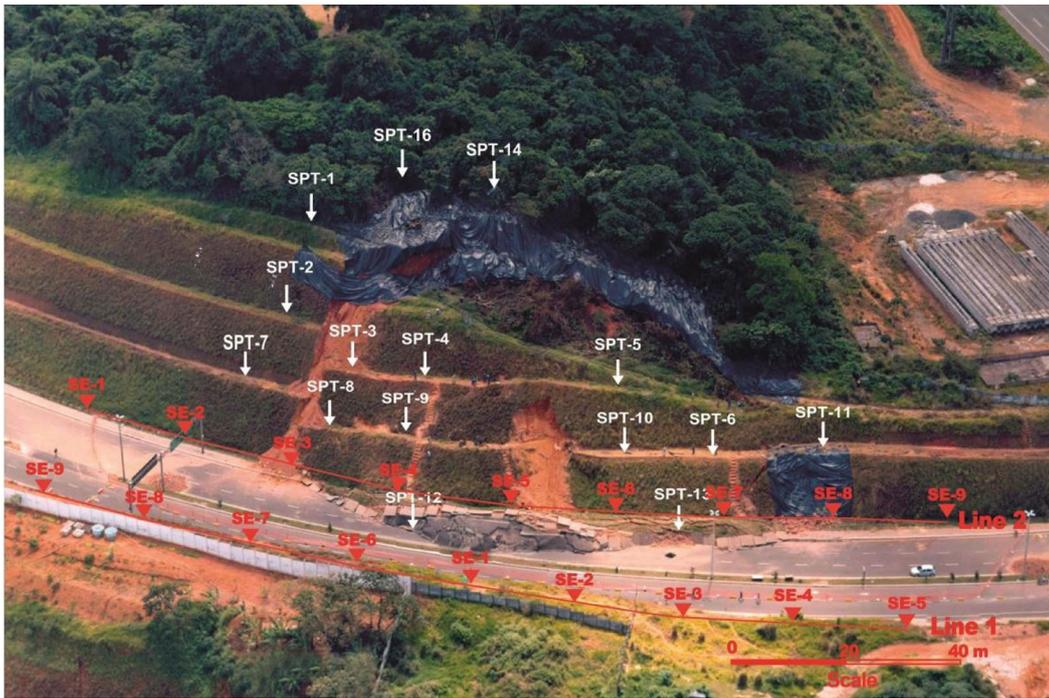
Figure 2 - Photo of the LEM Avenue landslide showing the geophysical and geotechnical layout. Adapted from (Benjumea, 2018).

The rainfall-induced landslide on LEM Avenue occurred on the 27th of August 2005, after a severe six-month rainy period in Salvador. The photo in Figure 2 shows that the wedge-shaped sliding block was bounded by a curved rupture surface, extending across one side of the road. The underground compression of the decomposed material uplifted the asphalt in one track of the road over 3.0 m height mound. Along several fractured surfaces within the sliding block, the altered material exhibits strong shearing, milonitization and an abundance of graphitic slicken-slides material. These are the main evidences to recognize the Morro do Águia fault damage zone crossing through the area, which partially control the sliding.

The photo of Figure 2 also depicts the layout of geotechnical drill hole locations and the disposition of the two geophysical cross-sections,

composed by spaced Schlumberger electrical soundings centered at the indicated positions, and also the approximated location of the referred water exploration well.

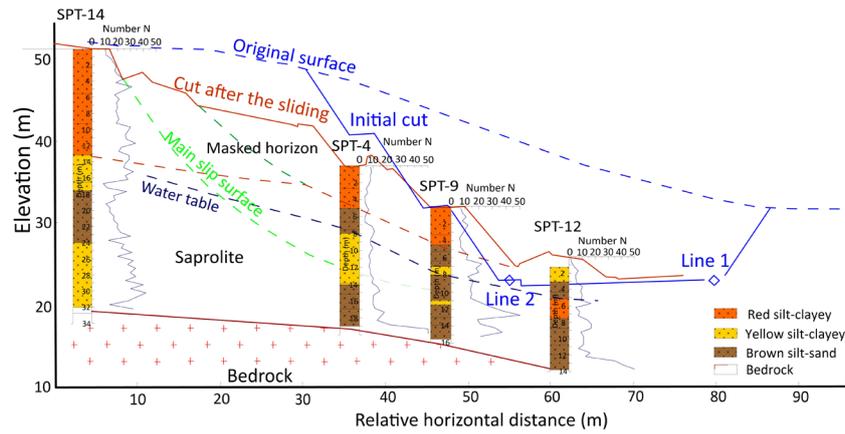
(a) - Geological, geotechnical and hydrogeological information of LEM area

Figure 3 - Geological, hydrological and geotechnical cross-sections and two drill holes for the main LEM sliding surface features before and after the accident. Adapted from Benjumea (2018).

Geotechnical testing comprising standard penetration percussion-drillings and detailed soil samples analysis were performed at 19 sites selected throughout the affected area. Figure 3a is a cross-sectional view of the road showing the following features: (i) the original hill slope surface; (ii) the cut surface allowing the road passage; and (iii) the topographic surface after the sliding event. Overlaying data from four SPT drill holes over this figure reveals a lithological zonation and the mechanical soil layer consistency to a depth of 20 m.

The SPT-14 well was located on a hilltop and closely reflects the original consistency of the non-disrupted, weathered layer. The soil strength was characterized by the number of blows (N) per 25 cm of penetration, which was normally above 20. The other three wells were located inside the sliding zone and exhibited a smaller cohesion, with an N below 10. In addition to providing these samples, the boreholes were also used to measure the groundwater level as depicted in Figure 3a. Figure 3 also shows the position of the

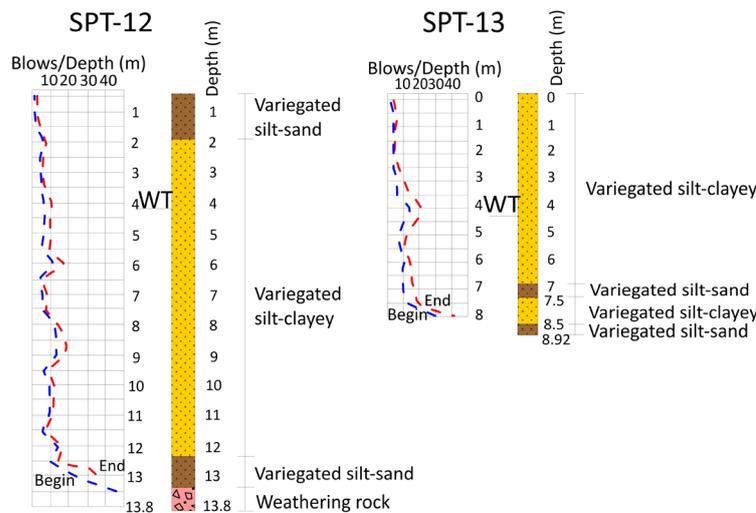
(b) - Drilling holes of SPT surveyed near to Line 2 in LEM area

geo-electrical survey lines and outlines the main surface rupture and another internal surface involved in the sliding event. The SPT-12 and SPT-13 were located in Figure 3b near to Line 2 of the LEM, depicted in Figure 2, with the goal of finding a good correlation between the geophysical data and the direct information extracted from the subsoil.

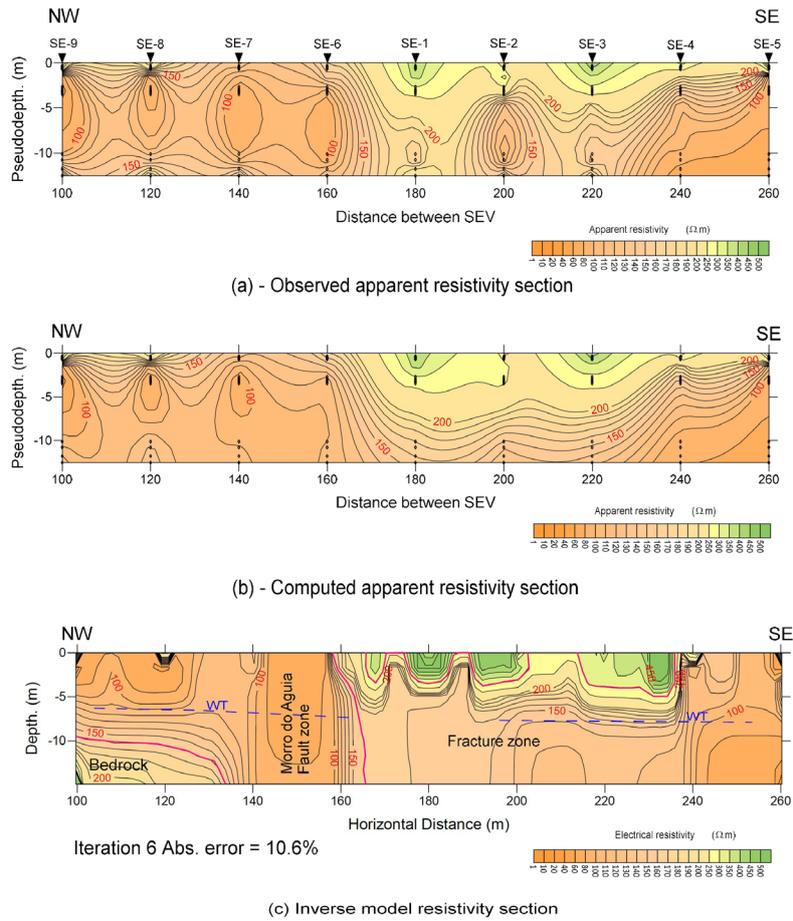
Figure 4 - Resistivity distribution along line 1 and the interpreted geo-electrical model.

The suitability of the inversion results were evaluated by the use of the mean absolute error between the measured and the computed apparent resistivity and chargeability values, for the number of points in each section. The inverted resistivity and IP models obtained in the area are shown in Figures 4 to 7 for lines 1 and 2, respectively.

The resistivity and IP distributions within the subsurface soil below line 1, which was less affected by the landslide (Figs. 4 and 5), exhibited large lateral variations in the upper soil materials. The high ρ_a and low m_a values in the upper zone, suggest it was highly porous and low water content in the central part. The water table depth varied from 6 to 9m, along the profile. The large IP values in the soil layer and basement block between soundings SE-7 to SE-9, should be related to the

dispersed graphite and other conductive minerals, which are strong sources for IP effects. A sub-vertical zone with intermediate resistivity and high IP values, between soundings SE-6 to SE-4, was related to the sheared damage zone in the Morro do Águia fault, and its densely fractured materials. In addition, it is observed a vertical structure of moderate resistivity and high IP values between soundings SE-7 to SE-6, also associated with the Morro do Águia fault.

The resistivity increase and chargeability reduction observed in the top layer, between soundings SE-4 and SE-6, were a result from the combined influence of topography and lateral electrical heterogeneities within the bulge created by the landslide. The absolute errors for this line, after six iterations, were of 10.9% and 1.7% for the concurrent resistivity and IP inversion.

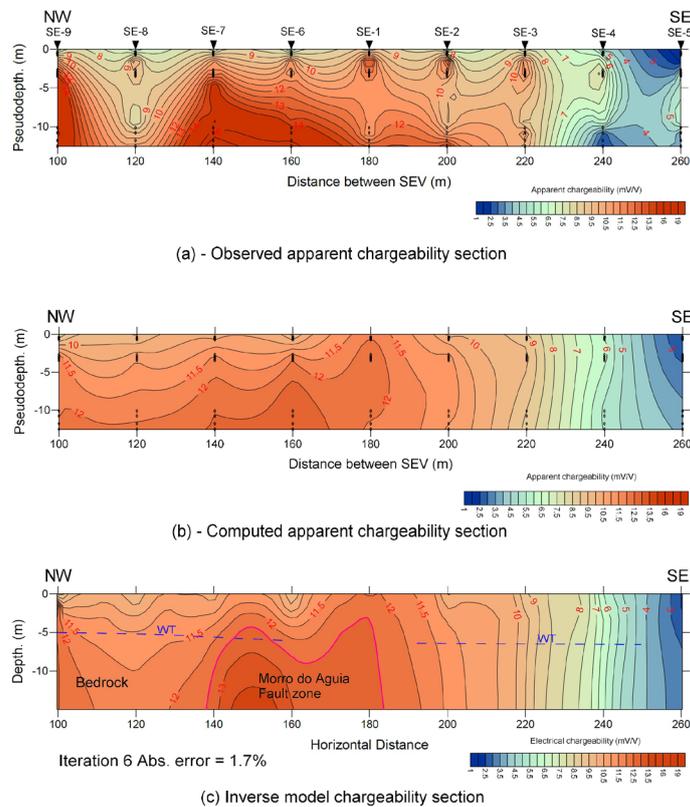
Figure 5 - Chargeability distribution along line 1 and the interpreted geo-electrical model.

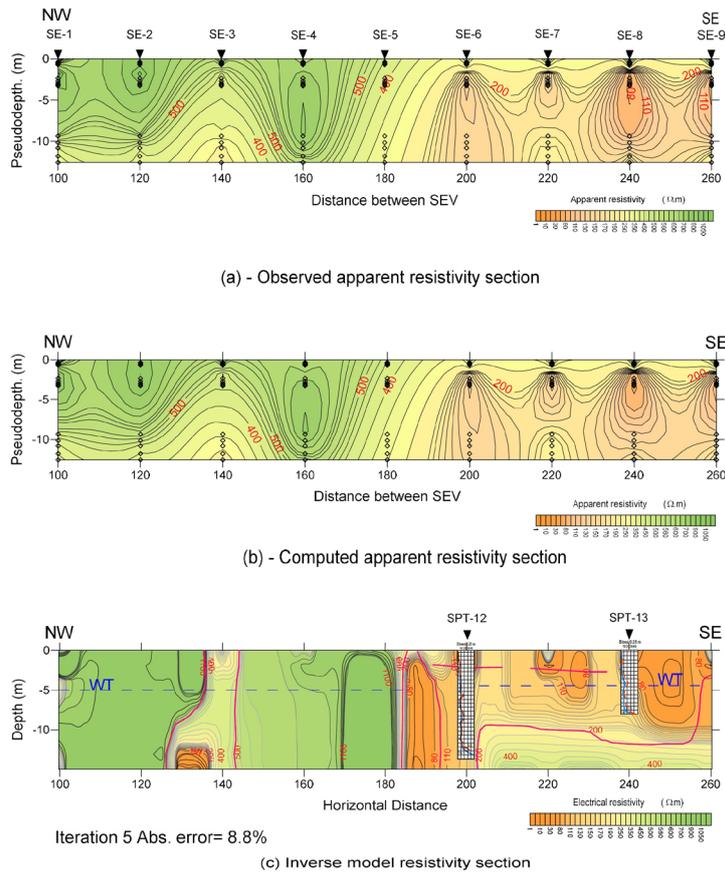
Figure 6 - Resistivity distribution along line 2 and the interpreted geo-electrical model.

Figures 6 and 7 show the pseudo-sections and the electrical-depth models for line 2 crossing through the uplifted side of the road. Both the resistivity and IP true images exhibited strong electrical contrast in the most superficial part of the weathered material. Such contrast was marked by a sharp resistivity transition above 600 Ω .m (green) to 60 Ω .m (orange). The IP effect was also strong within this upper layer. For this line the absolute errors, after five iterations, were of 8.8% and 1.3%, respectively.

Beneath this variable soil covering the crystalline, partially altered rocks (below 9 m depth) were determined by several sub-vertical electrical structures. The most notable was located in the central-eastern portion, between soundings SE-5 and SE-9. It has low resistivity values and moderate chargeability and contained the most sheared portion of the Morro do Águia fault zone. There was a wide transitional zone with intermediate resistivity, considered to be a thick permeable portion of the fractured basement unit.

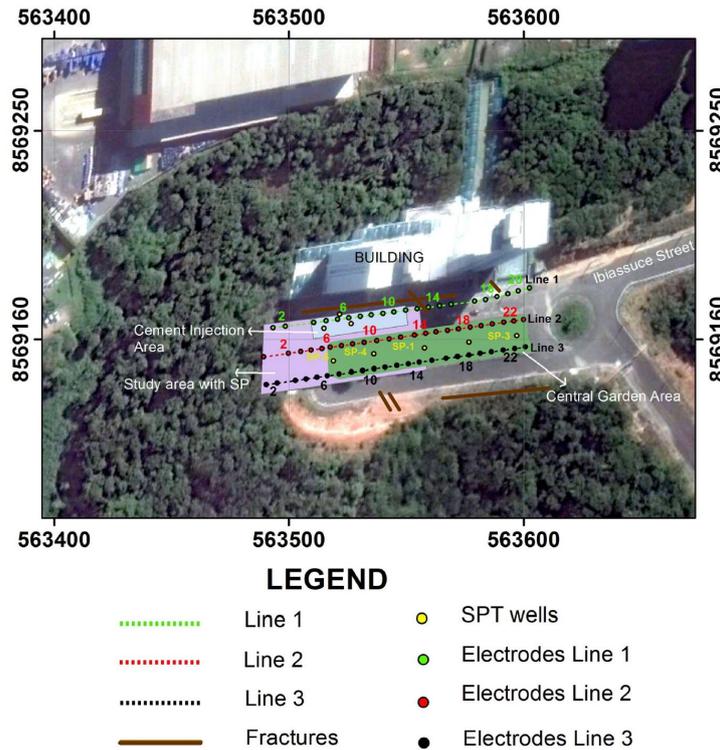
Figure 8 - Building data and survey line layout on a Google image of the LVF area having hydrologic and geotechnical problems.

Given that this infiltration may cause slippage and local instabilities within the sloped terrain, cement was injected into boreholes opened in the side of Ibiassucê Street, as shown in Figure 8, to

The topographic map in Figure 8 shows some fracture lineaments identified by deep grooves in satellite images from Google Earth and through direct observation on lateral road cuts accessing the area.

Figure 9 also shows the underground configuration of the water table depth within the central Ibiassucê Street garden. The saturated flow proceeded from west to east along the main building fronts. The topographic descent in the embankment obscured the infiltration and sub-saturated flow occurrence within the vadose zone of the aquifer. Inside the buildings the surface and subsurface runoffs were oriented approximately northeast, along the surface drainage course (Fig. 8).

The hydrodynamic goals defined above were achieved via geo-electrical methods using a multi-profiling technique, measuring simultaneously the electrical resistivity and the time-domain induced polarization of the subsurface geology. Three geo-electrical cross-sections were surveyed along the blue lines shown in Figure 8.

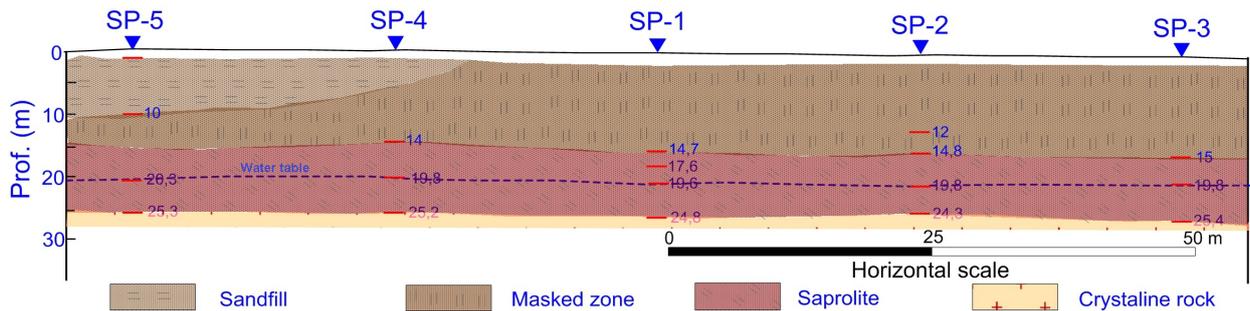
Figure 9 - Geologic and geotechnical cross-section along the LVF area showing the weathered horizon zonation.

Geotechnical percussion drill holes were used to identify four horizons of different litho-mechanical constitutions within the area. The geological cross-section in Figure 9, constructed based on five SPTs, show the vertical distribution of these units, which were characterized as follows: (i) the upper layer, dominant in the western area, based on its composition and low cohesion was identified as a cut and fill soil layer created during the road construction; (ii) a masked leached horizon rich in quartz and other resistant minerals, which exhibited a medium to moderate mechanical cohesion; (iii) a saprolitic horizon of altered rock with some textural and compositional elements preserved from the original altered rocks, and usually characterized by high cohesion; and (iv) the fresh or slightly altered rock zone, which was virtually impenetrable to percussion.

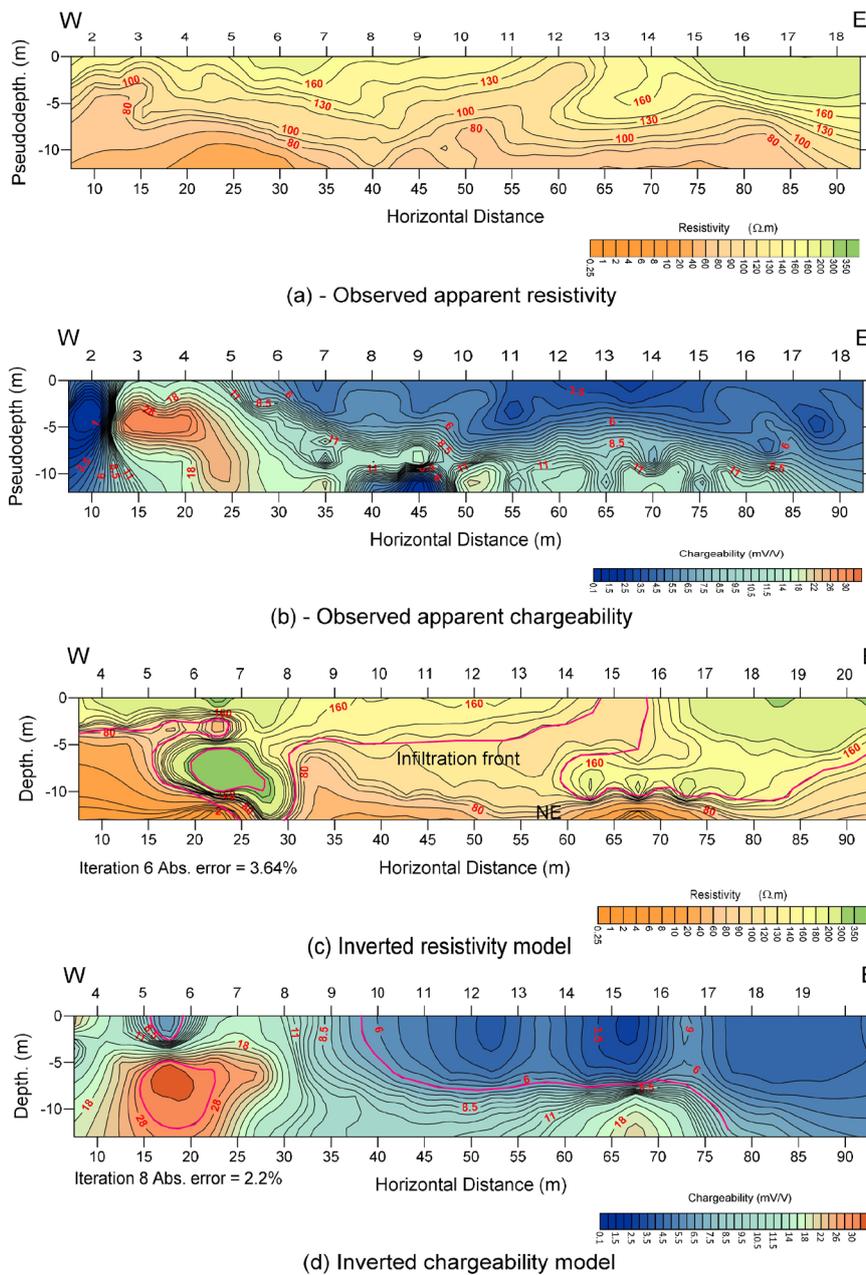
Figure 10 - Resistivity and chargeability distribution along line 1 (LVF area) and the interpreted geo-electrical models.

Figures 10 through 12 show the results from the three geo-electrical cross-sections detailing the subsurface hydrology around the main exudation

area. These figures contain the observed and computed apparent resistivity and chargeability data, and the two inverted models for the true resistivity and chargeability of the subsurface geology. To unify the analysis, it was used the same ranges of values representing resistivity and chargeability data.

Solved the negative resistivity question, it was discussed the inverted results of 2-D electrical images obtained with the RES2DINV package, which produced the final inverted resistivity and chargeability models shown in Figures 10c and 10d.

The resistivity model (Fig. 10c) suggests that the altered materials down to a 3.5 m depth exhibited a moderate resistivity (above 150 $\Omega.m$). The blocks marked as A and B have true resistivity well above 800 $\Omega.m$, and show low to moderated IP effect. They are certainly related to the large amount of cement injected for draping the regolith below the indicated area in Figure 8, and also in the underground supporting structure for the buildings.

The chargeability model (Fig.10d) shows high values (> 30 mV/V) in the western portion, which correspond to the conducting zone described above, and supports a higher porosity and water content above and to the west of the cemented block. Several shallow areas (up to 6.0 m deep) with high chargeabilities seem to indicate the presence of buried metals used in the building infrastructure.

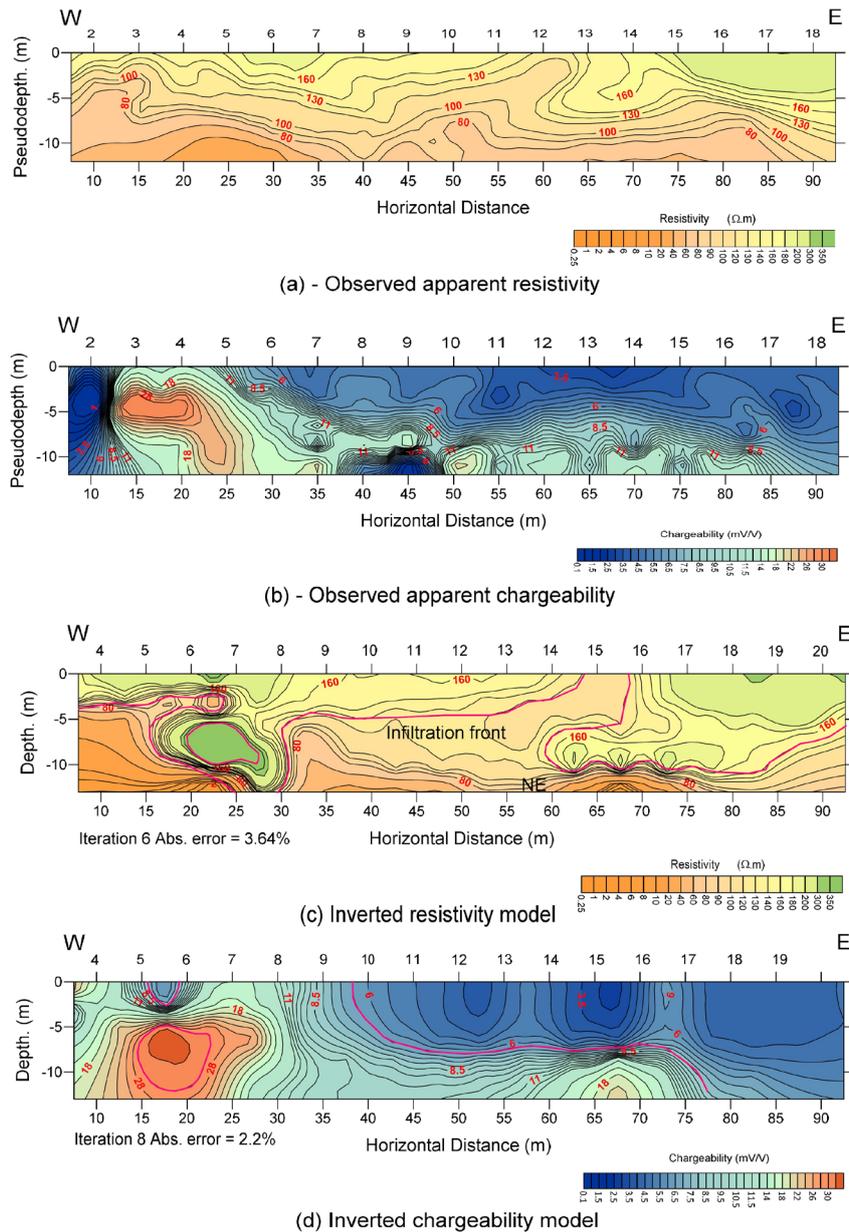
Figure 11 - Resistivity and chargeability distribution along line 2 (LVF area) and the interpreted geo-electrical models.

Figures 11 and 12 show the results for lines 2 and 3, respectively, which are 12.8 m and 25.6 m south of line 1. Only three electrodes were positioned in the asphalt holes at the end of the area (Fig. 8). No negative apparent resistivity values were registered along these two lines. The inversion yielded a 4.2% absolute median error in resistivity, after six iterations.

The final resistivity model for line 2 identified the following elements: (i) an upper layer with low saturation and resistivity above 120 Ω .m, with lateral variations observed mainly in the central part of the profile; (ii) a conducting interval over 5.0 m thick that sloped from east to west, and associated with a higher degree of saturation (infiltration front). This area seemed to grow from east to west, with a ring of almost complete saturation in the western section; (iii) the conductive capillary fringe zone was practically leveled below 12.5 m; (iv) one highly resistive block of limited lateral extent, located between stations 6 and 7, appears as resulting from the lateral influence caused by the underground cementation zone. The IP data more tenuously reflect the variation in saturation with depth and its increase in the western part of the profile. The statistical fittings were of absolute mean errors of 3.64% and 2.2%, for the concurrent resistivity and IP inversion after six iterations.

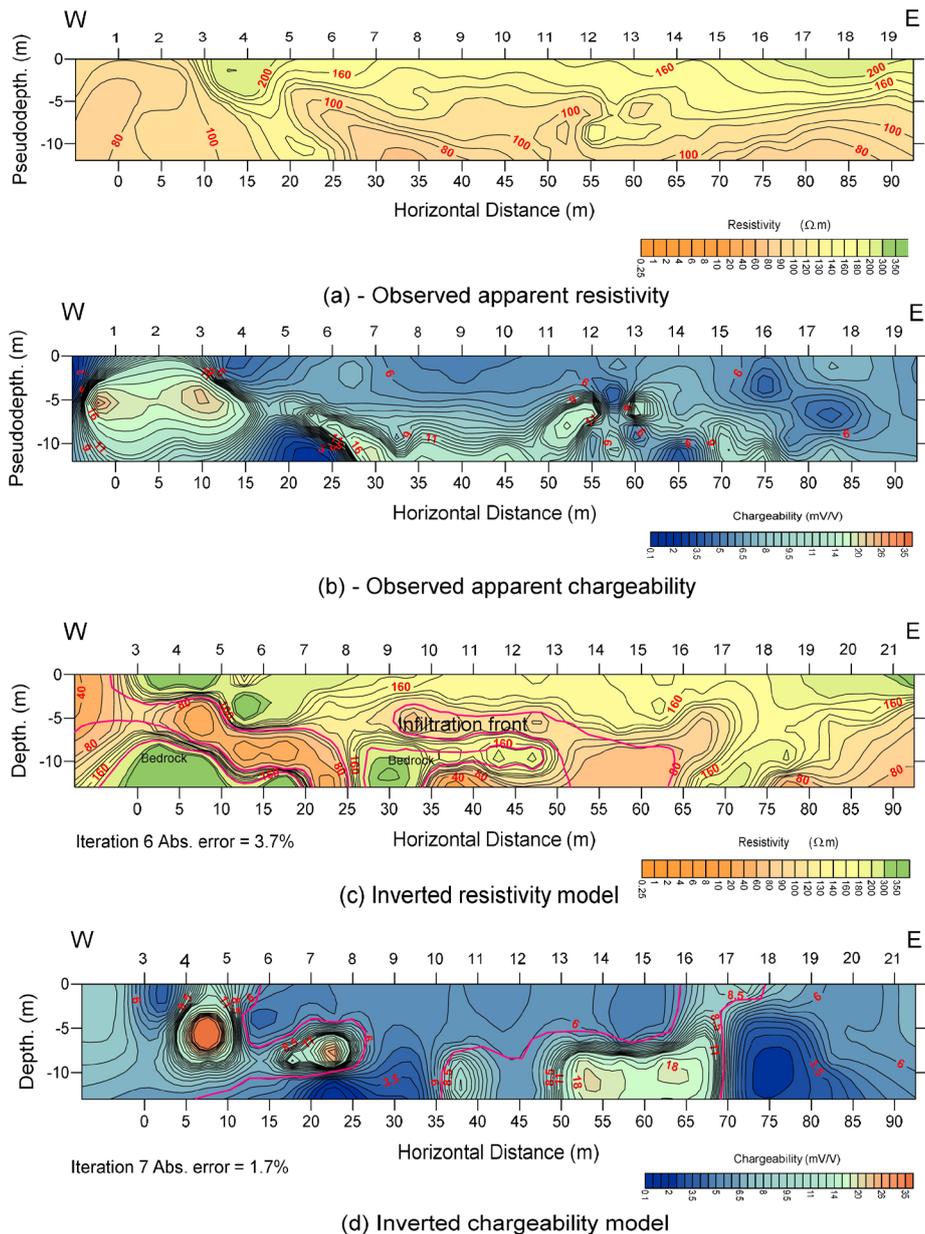
Figure 12 - Resistivity and chargeability distribution along line 3 (LVF area) and the interpreted geo-electrical models.

For line 3 (Fig. 12), the adjusted electrical models indicated a persistent conductive and chargeable sub-horizontal layer between depths of 5 and 11m. This layer was sandwiched between more resistive and less chargeable horizons, which suggest a rainwater infiltration front, advancing downward to

recharge the crystalline aquifer. Remarkably this front is slightly deeper in the western section, which suggests rapid progress along a more permeable belt in the regolith. The western portion of the section has a lower resistivity and high IP, suggesting a large increase in water content and a faster progress of flow along a permeable zone inside the regolith. Yet the lateral effects caused by the cemented block were notable. The statistical fits for these results also yielded absolute median errors of 3.7% and 1.7%, after six concurrent iterations.
